**PHASE I ENVIRONMENTAL  
SITE ASSESSMENT**

Timminco Property  
10380 Smith Road  
Aurora, Colorado

Freedom Project No. 0606-076

December 18, 2006

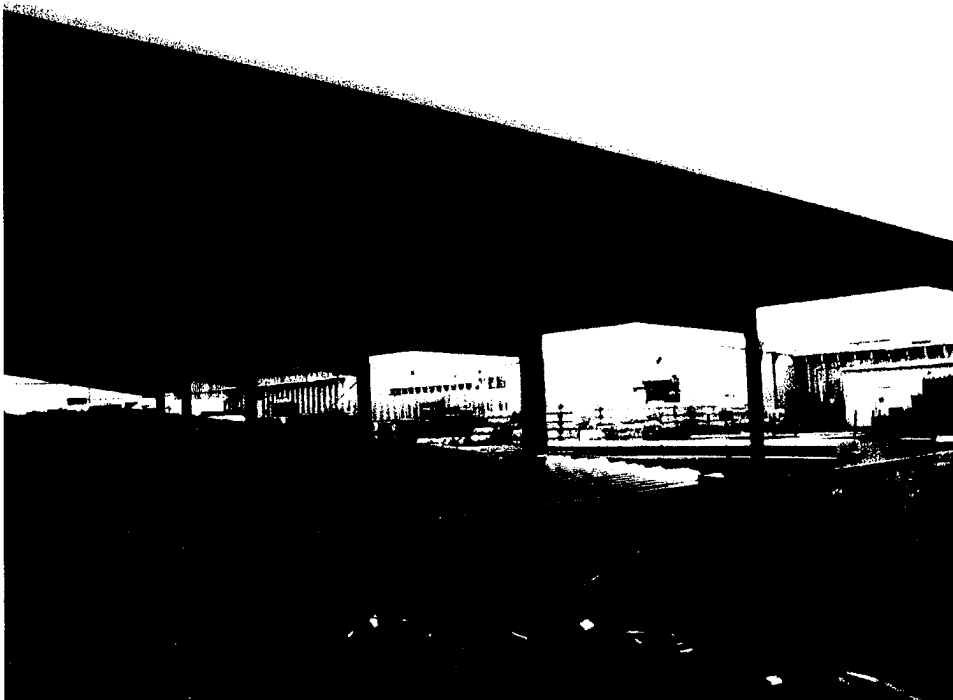
Photo #4: View southeast toward the covered storage area. The silver rolls are extruded magnesium that is ready for further use.

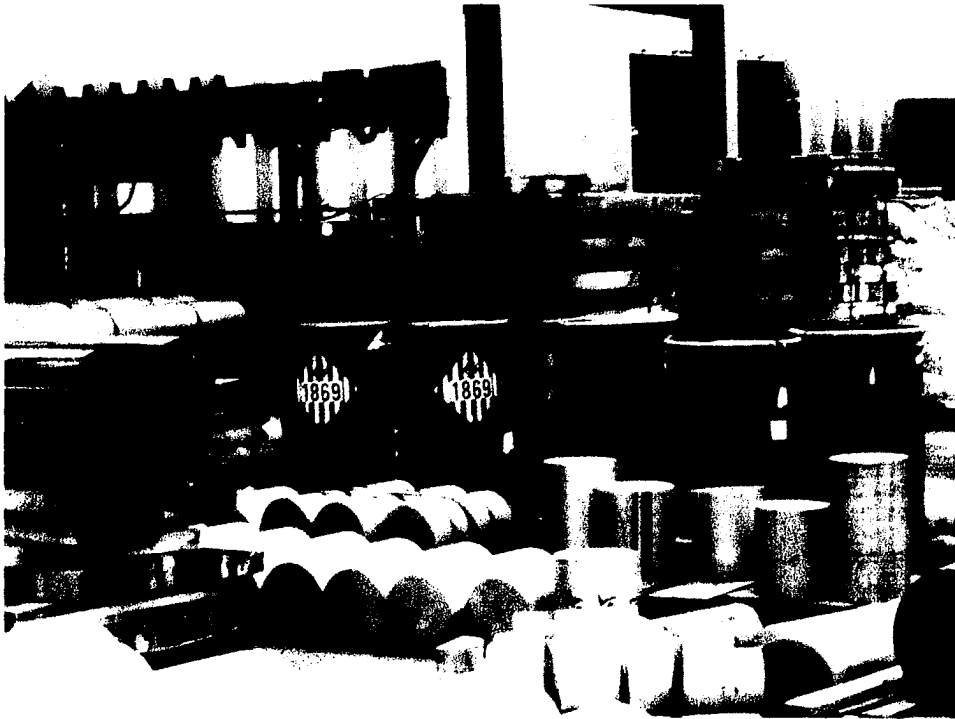
Photo #5: Raw metal product and scrap metal in the drums.

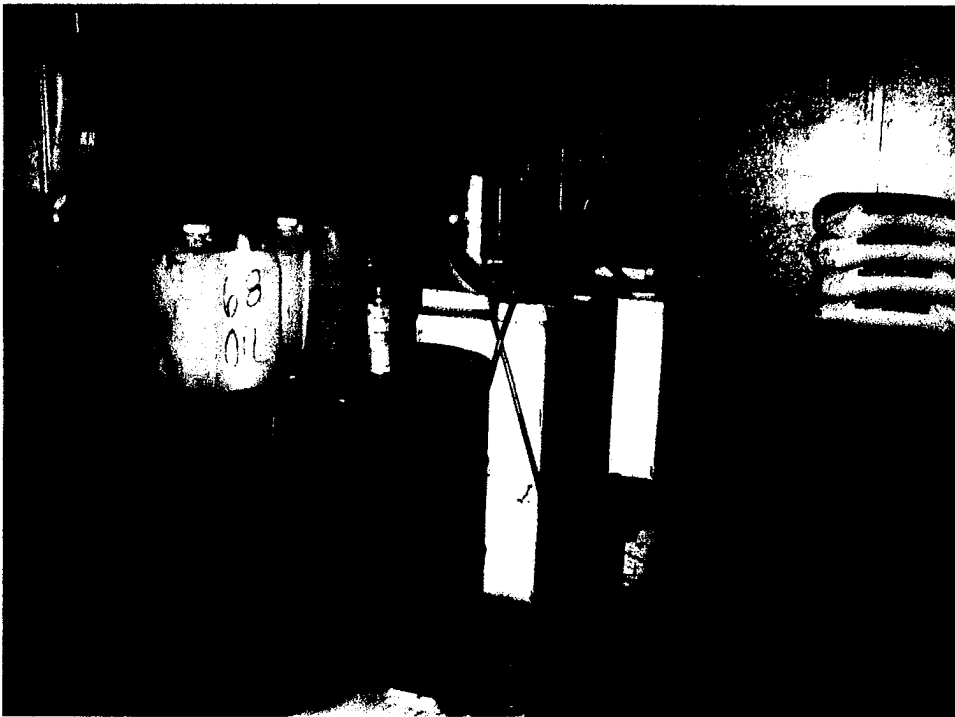
Photo #7: Oil storage, lube, and sorbant storage in the north building.

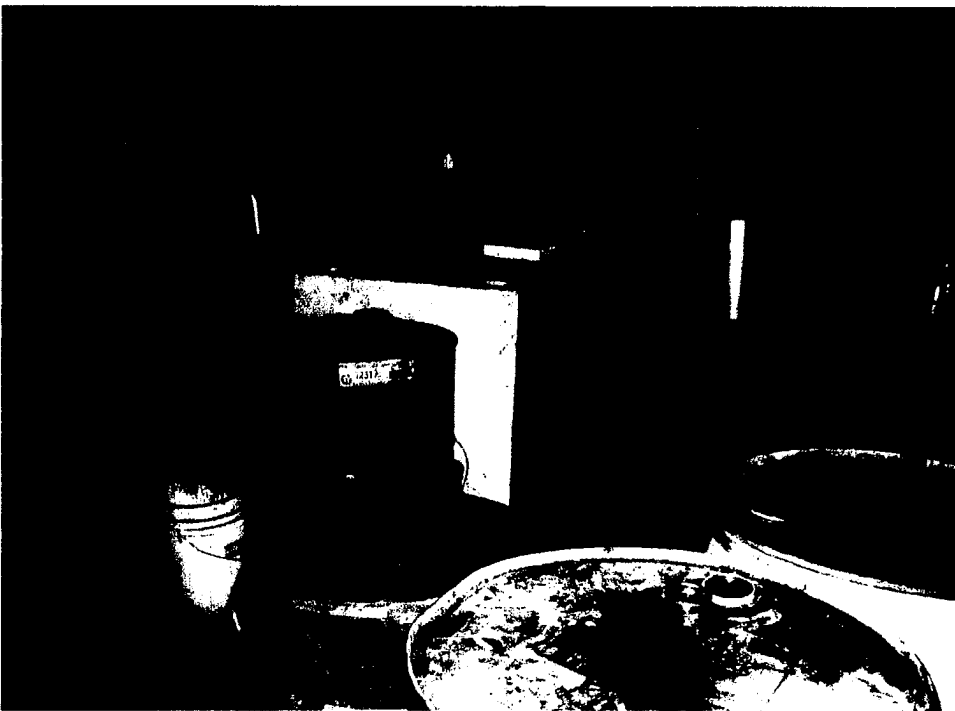
Several areas of the south building appeared to have significant staining on the concrete floors. It appeared to be significant as a result of accumulation over many years. However, no floor drains were in the areas and the staining is not considered a REC for the site.

Photo #8: Drums of oil, lube, rust inhibitor and other chemicals within secondary containment in the south building. There was significant staining on the concrete floor, but it is not considered a REC

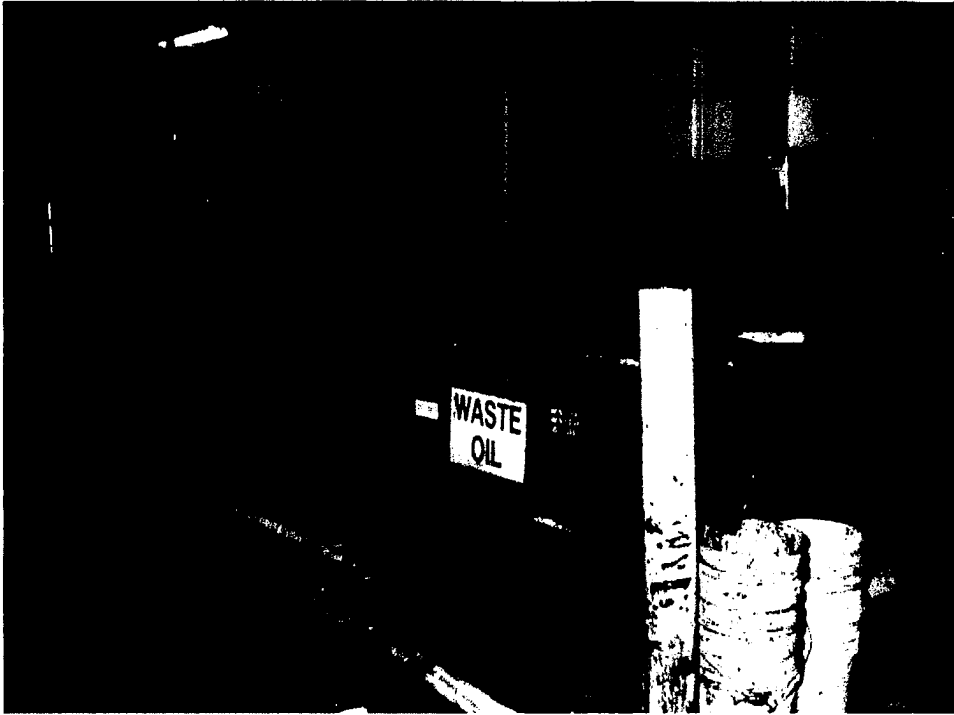
Photo #9: Oil and used oil storage adjoining the press room in the south building.

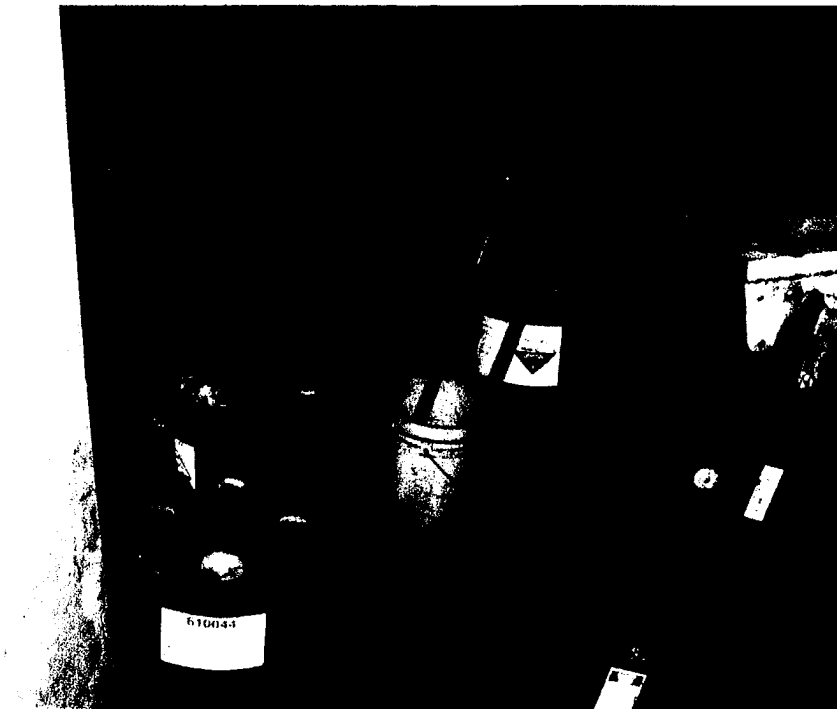
Acid and caustic baths were observed in the south building. Mr. Keeling reported that they are emptied periodically and Clean Harbors manages the wastes. 50-pound bags of soda beads also were present in the area to control pH in the baths.

The concrete in the area of the acid and caustic baths showed some corrosion. Because of the nature of the chemical use in that area, it is not considered a REC.

Photo #10: Drums of chemicals next to the acid and caustic baths. The back wall of the baths are at the left. (No good photos of the actual baths were usable).
